Experimental Investigation on Cracks in Concrete Road Pavement

Abhay Shelar¹, Rakesh Kumar², Supriya Shinde³, Shital Patage⁴

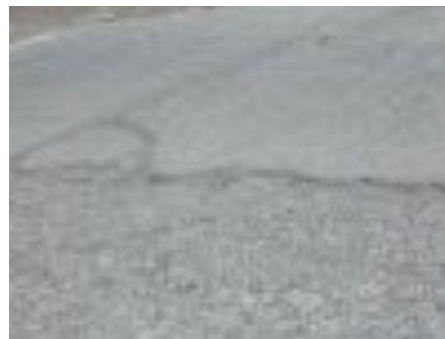
A transverse fracture or corner break indicates failure of the load transmission mechanism at the joint. Dowel bar misalignment and rust are two potential causes of this failure. Tensile stresses are induced around the dowel bar by the corrosion byproducts, which occupy a specific volume, and the excess corrosion weakens the dowel bar, which may collapse prematurely under repeated loading. Dowel bar bending and proximity to the slab edge will cause localized pressures that might be sufficient to crack the pavement. After the failing joint load transfer system is replaced, the pavement is typically rebuilt with a full-depth patch at the damaged location.

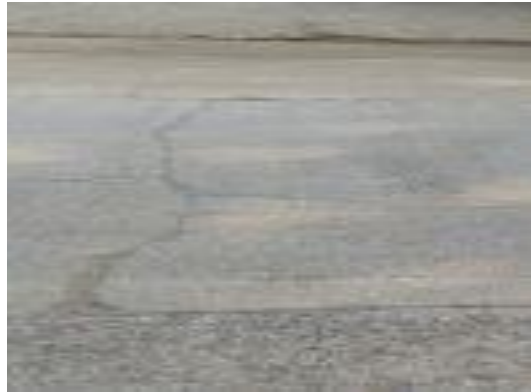
Slabs are broken into more than two pieces by the linear fissures that run the length of each one. Panel cracking is another name for the phenomena known as linear cracking. The riding quality of

the pavement will suffer as a result of linear cracking. Loss of soil support for the pavement may occur if linear cracking allows moisture movement in the pavement body, which in turn may cause erosion of the base or subbase. The gaps might spread and fall apart if they aren't sealed. Linear cracking may be brought on by a variety of factors, including excessive foot traffic, a drastic change in temperature, the curling of slabs, moisture pressures, or a lack of soil support. Linear cracks may be repaired using a crack sealer. Full-depth restoration is used to rehabilitate pavement if linear cracking progresses to panel cracking.
