An Experimental Investigation on Optimum Percentage of Nano-Silica in Nano-Mortar/Nano-Concrete for Retrofitting of RC Structures

The purpose of this study was to introduce a proposed method to retrofit RC beams. This paper consists of study of the RC beam behavior after using Nano Silica, Carbon Fibre Reinforced Polymer (CFRP), Glass Fibre Reinforced Polymer (GFRP) and epoxy in order to attain maximum strength, so as to withstand the shear forces, bending moments and other related structural response parameters efficiently. For this purpose, casting of three sets of reinforced concrete (RC) beam. Failure modes of each of the beams were obtained. The change in load carrying capacity and failure mode of the beams were investigated. The laboratory experiment and numerical simulation were used to investigate the behavior of the beams. Three RC beams for three different condition such 10mm U shape Nano silica retrofitting, RC beam with CFRP external wrapping retrofitting and without retrofitting specimens were investigated.

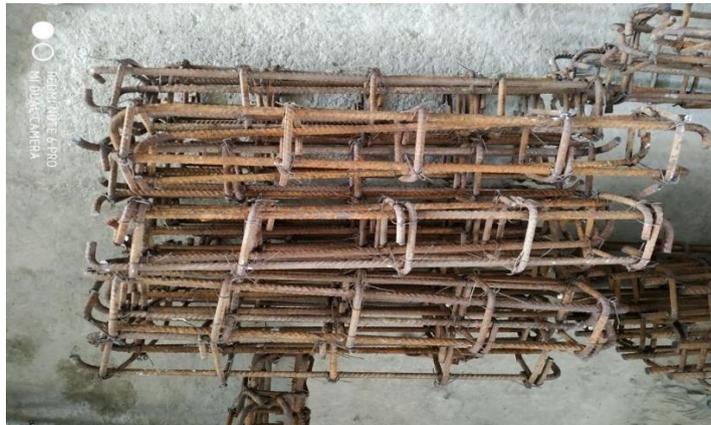
Fig. 2 Reinforcement specimen of beam

In the present study fourteen R.C.C. beams are casted and categorized into three groups. The beam has a cross section of (150 ×150) mm with an overall length of 700mm. The beams were reinforced with 2 Nos. of 10 mm HYSD Fe500 bars at the top and bottom respectively and stirrups were made up of 8 mm bars and were provided at a distance of 150 mm C/C.

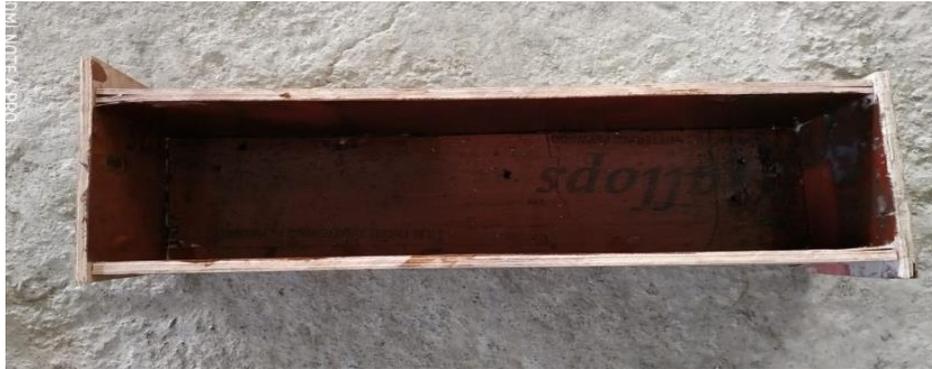
Fig. 2.1 Form Work details of beam

The formwork made from plywood was used for the casting of beam. The formwork was made of the dimension 150 mm x150 mm x700 mm.

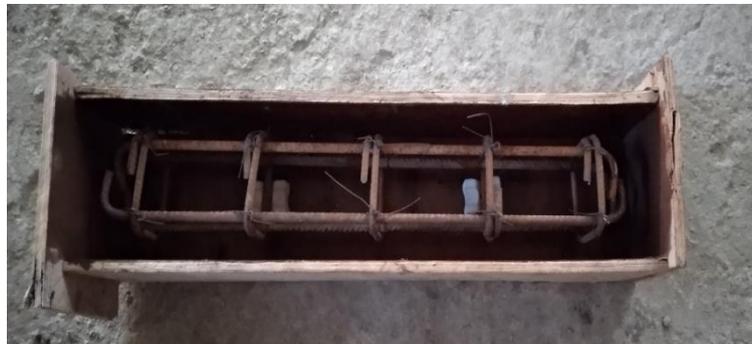
Fig. 2.2 Steel Frame Used for Casting of Beam

The steel frame was made up of 10 mm and 8 mm HYSD bars. The reinforced concrete beam was provided with an effective cover of 25 mm.

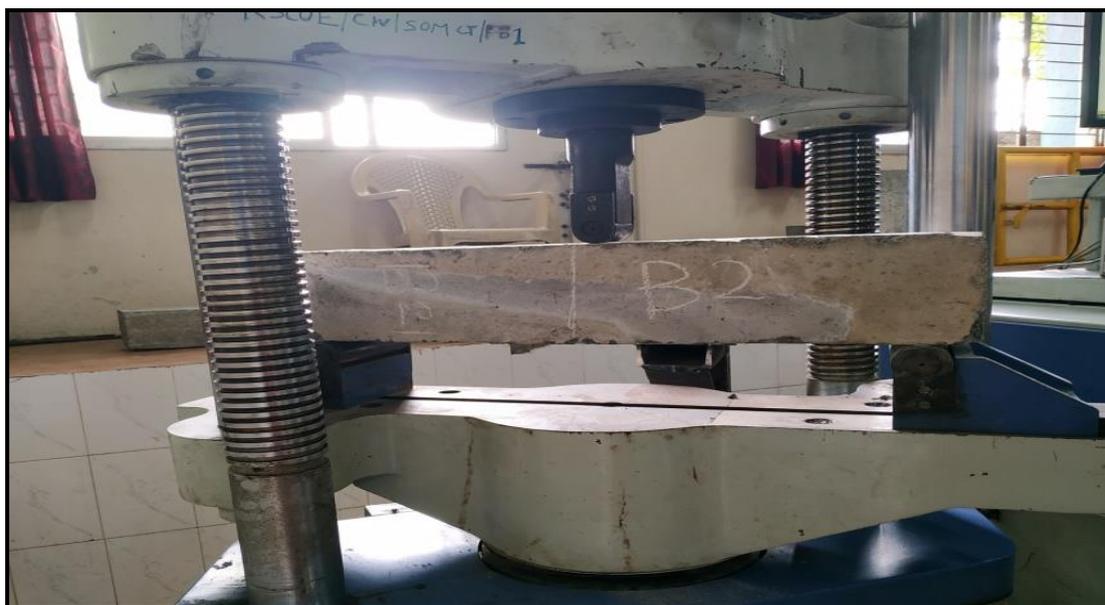
Fig.3.2.1: Beam specimen for testing

Fig 3.2.1 show beam specimens kept ready for testing. The testing of beam consists of three sets of reinforced concrete (RC) beams. In set I total three beams were casted for full failure to observed ultimate load. The test was continued until the load drops about 40-50% of the obtained ultimate loads for concrete beam specimens. All the beams were tested till they reach their full flexural capacity. The behavior of the beam was keenly observed from the beginning to the end till it collapses.

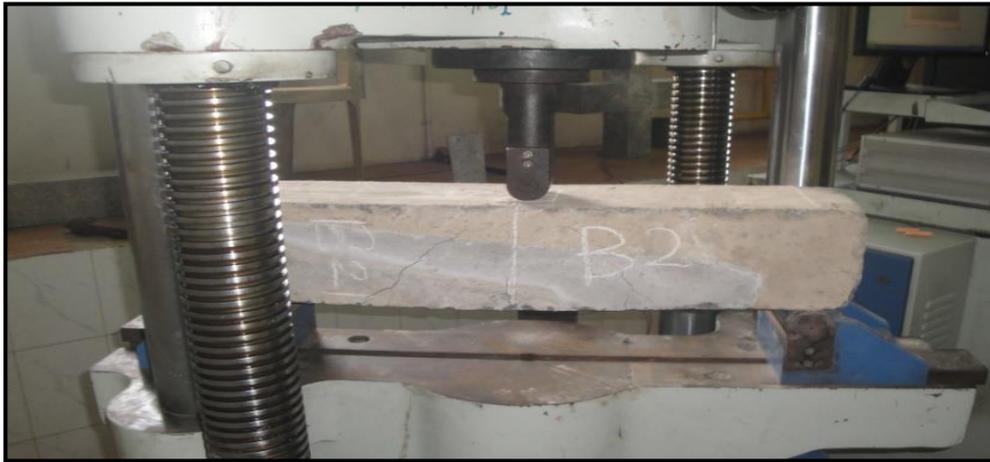
Fig.3.2.2: Beam during loading

The beam failure took place either due to crushing or shears failure up to 83 KN in compression zone and failed with sufficient warning before collapse. The crack patterns were also recorded at every load increment. It has been observed that hairline cracks develop at the lower part of the beam and as loading continues, cracks widen and extend towards the neutral axis. At the time of loading rate was maintained as low as possible and constant.

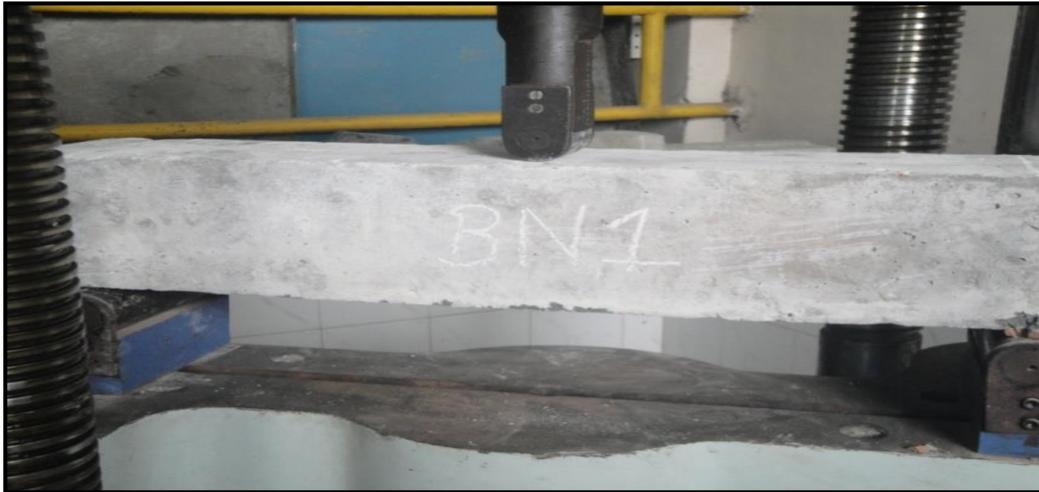
Fig.3.3.1: Simply supported beam testing

In SET II three beams are casted and tested, the three beams were retrofitted by using Nano silica. In SET III three beams were casted and tested up to first crack, and all three beams were retrofitted using continuous glass fiber reinforced polymer (GFRP) sheets.

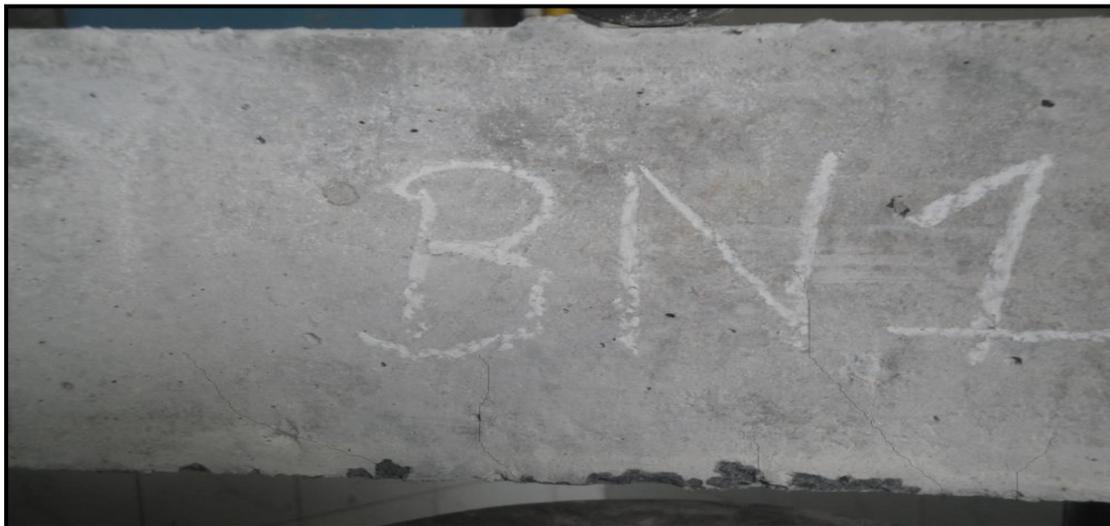
Fig.3.3.2: First crack on beam

The beam failure takes place either due to shear failure up to the first crack. The crack patterns are also recorded at every load increment. It has been observed that hairline cracks develop at the lower part of the beam and as loading continues, cracks widen and extend towards the neutral axis. At the time of loading rate should maintain as low as possible and constant.

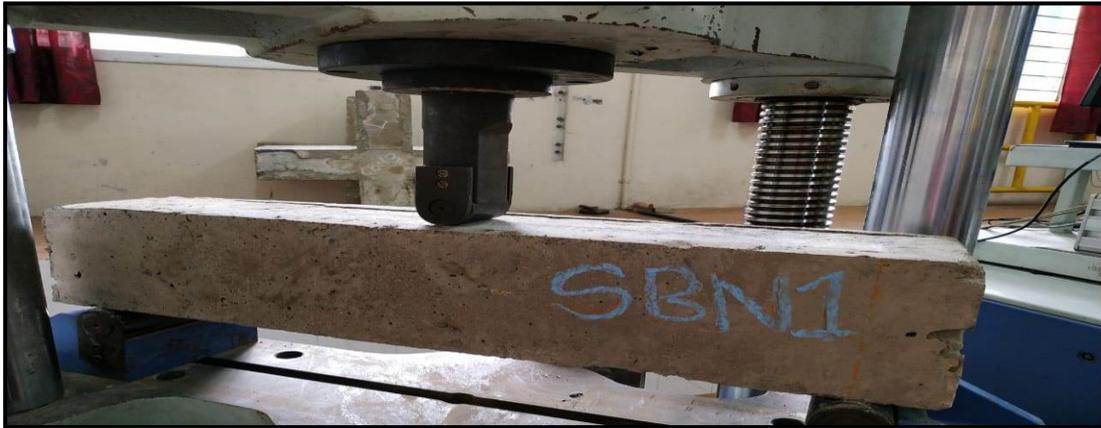
Fig.3.4.1: Beam specimen for testing

In SET III three beams were tested for full failure. Figure 3.4.1 shows beam specimens kept ready for testing. The testing of beam consists of three sets of retrofitted reinforced concrete beams. We measure the width and thickness of a specimen and mark all the points where the load is to be applied. Under the centre point loading process, place carefully the sample on the stage of UTM such that the loading point is set at the pointed location.

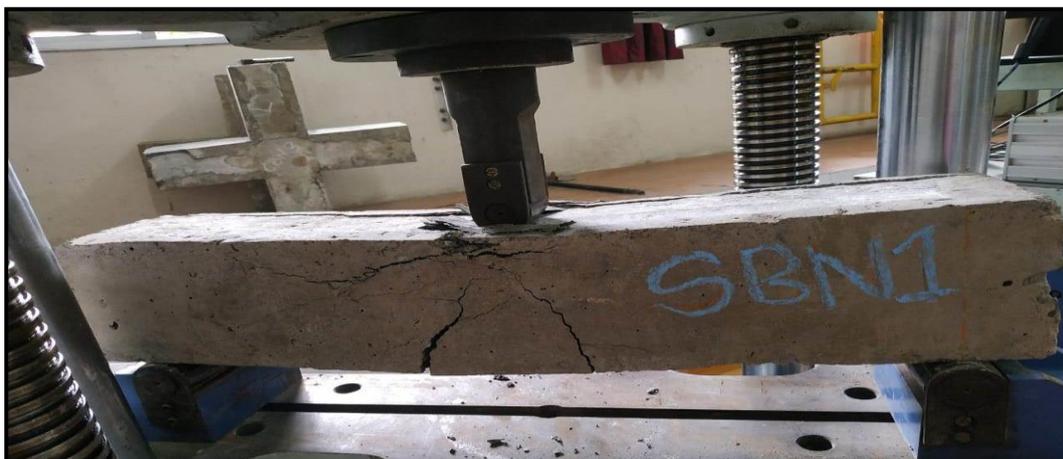
Fig.3.4.2: Failure retrofitted beam using nano silica

The crack patterns are also recorded at every load increment. It has been observed that cracks develop at the lower part of the beam and as loading continues, cracks widen and extend towards the neutral axis. At the time of loading rate should maintain as low as possible and constant.

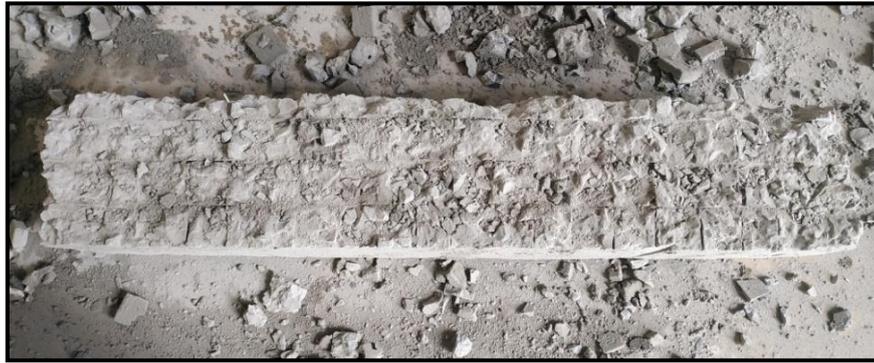
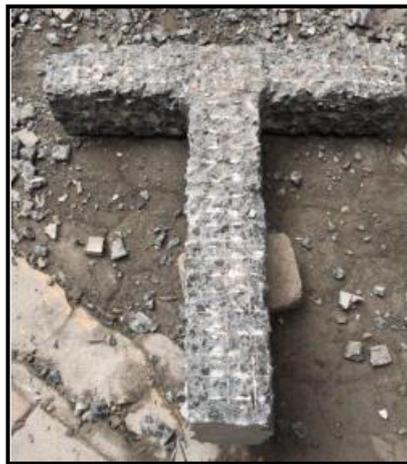
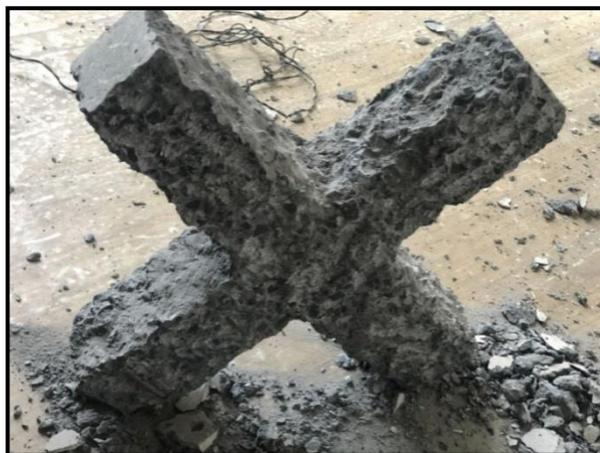
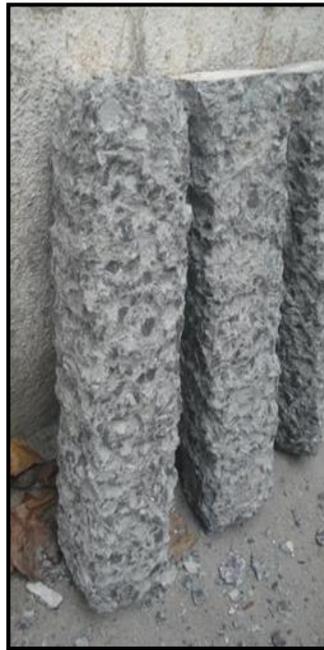
specimen by nano silica mortar. By taking all the precautions the cover of beam was removed manually. Figure 3.5.1 to 3.5.4 shows cutting of damaged portion of specimens for retrofitting.

Figure3.5.1: Cutting of Damaged Portion of Simple Beam Specimen for Retrofitting

Figure3.5.2: Cutting of Damaged Portion of T-Beam Specimen for Retrofitting

Figure3.5.3: Cutting of Damaged Portion of Cross Beam Specimen for Retrofitting

Figure 3.5.4: Cutting of Damaged Portion of Column Specimen for Retrofitting

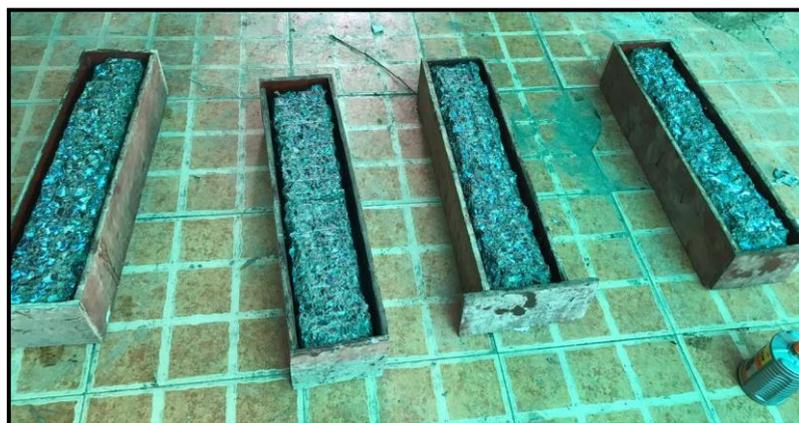
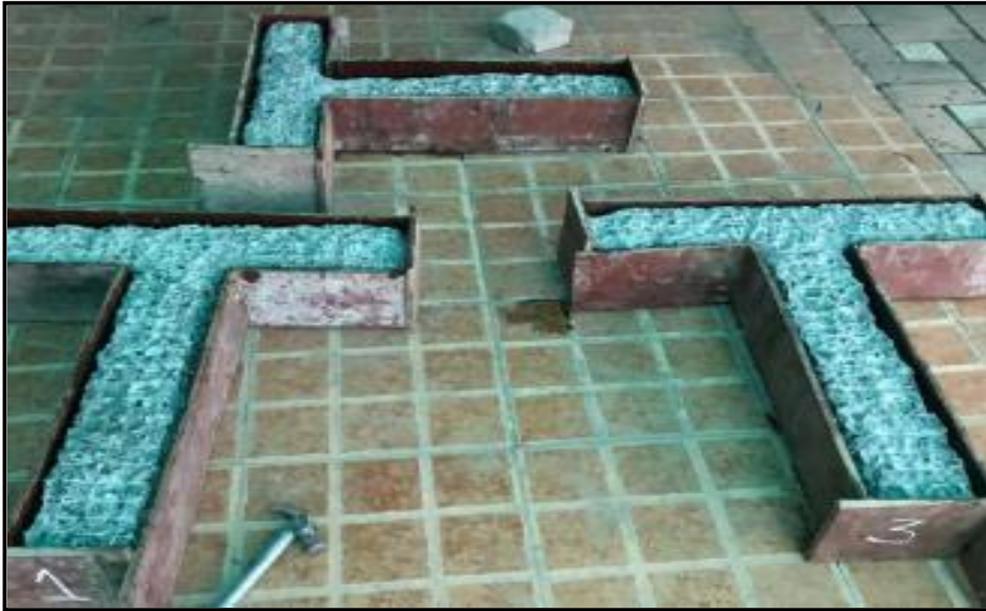
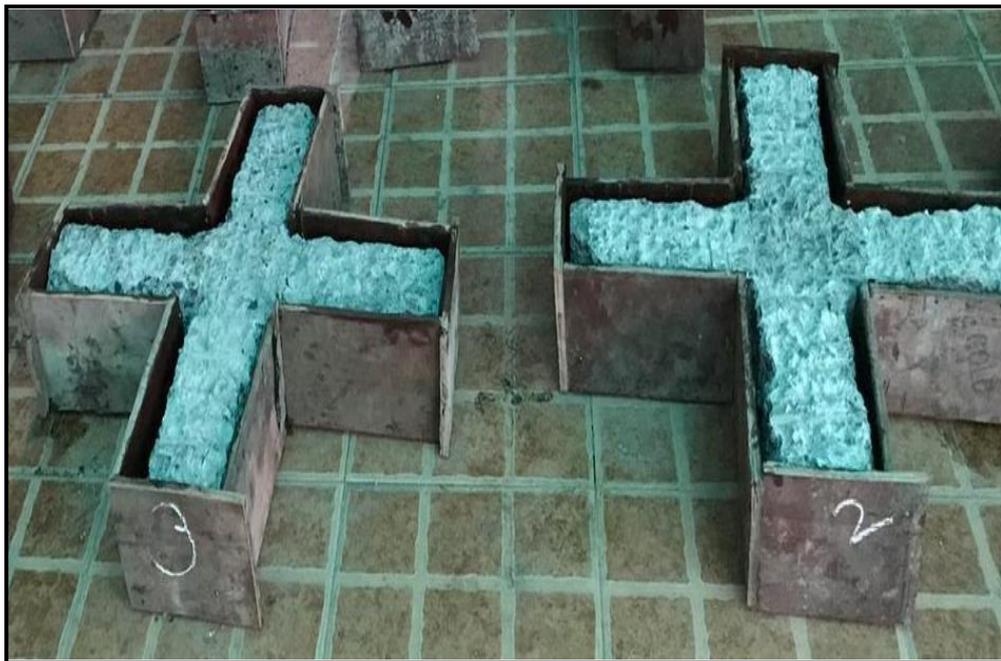
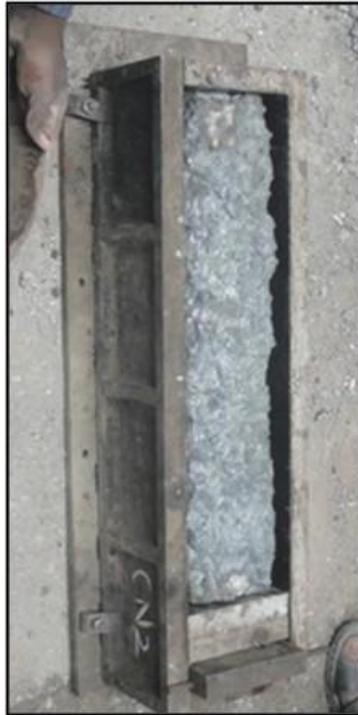
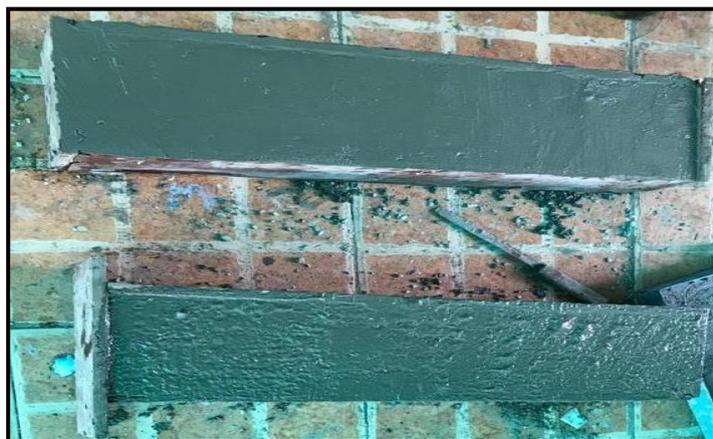
As 0.5% replacement of cement by nano silica gave maximum increment in strength as explained in section 3.2, specimens were retrofitted with mortar mix design for the same. After the nano silica mortar has been mixed, and filling of mortar was done by using the same moulds used for concreting. The compaction of the mortar was done manually by using tapping rod. After filling of nano silica, the dimensions of beam were checked. Figure 3.6.1 to 3.6.5 shows moulding of specimens before filling of nano silica mortar and Figure 3.49 shows specimens retrofitted with filling of nano silica mortar.

Figure 3.6.1: Moulding of Simple Beam Specimens before Nano Silica Retrofitting

Figure3.6.2: Moulding of T-Beam Specimens before Nano Silica Retrofitting

Figure3.6.3: Moulding of Cross Beam Specimens before Nano Silica Retrofitting

Figure3.6.4: Moulding of column Specimens before Nano Silica Retrofitting

Figure3.6.5: Filling of Nano Silica Mortar

After filling of the mortar, setting of the specimens were done for 24hours and then kept for curing for 28days from date of casting.

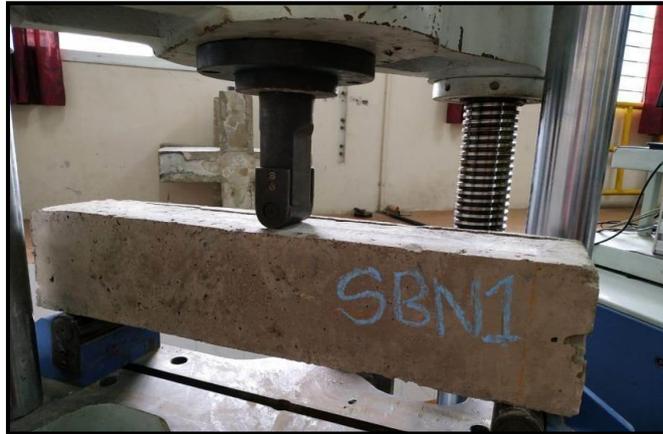
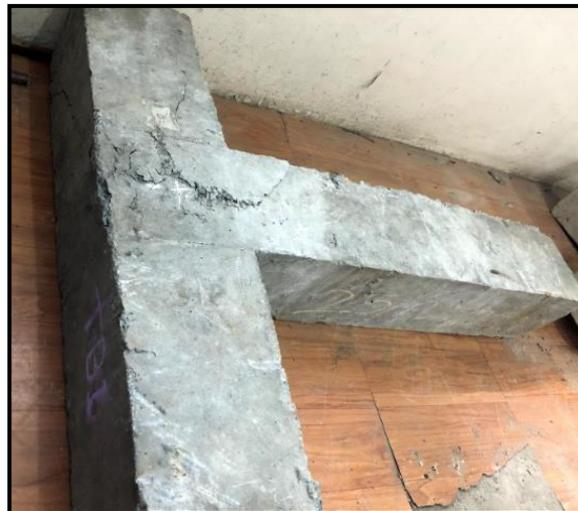
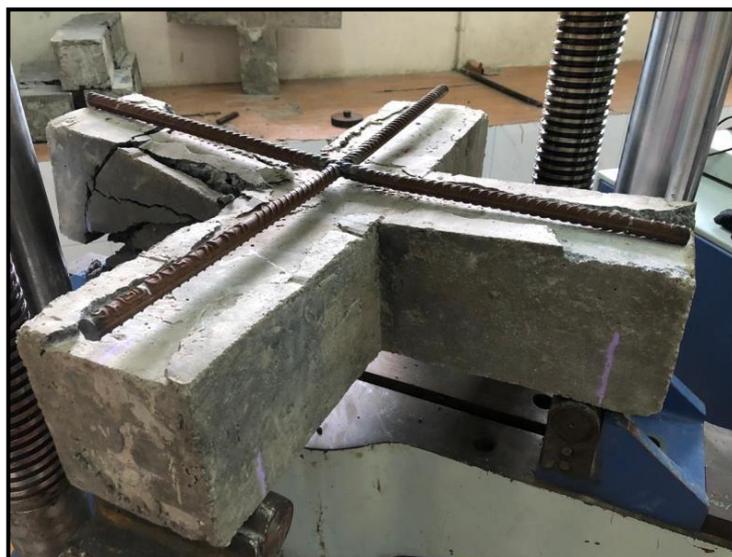
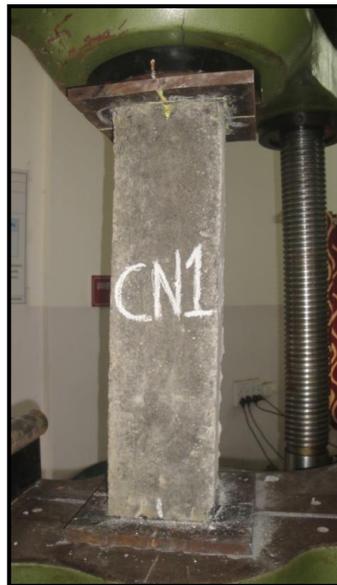
The SETII specimens retrofitted with Nano Silica were tested as per the procedure explained in section 3.6. Before testing the specimens, all dimensions were checked. The test setup and procedure were the same as for SET I. The specimens retrofitted with nano silica were tested up to the ultimate/failure load. Figure 3.6.1 to 3.6.4 shows sample images of specimens retrofitted with nano silica. The failure loads and the crack patterns were recorded at every load increment.

Figure3.6.1: Testing of Nano Silica Retrofitted Beam Specimen

Figure3.6.2: Testing of Nano Silica Retrofitted T-Beam Specimen

Figure3.6.3: Testing of Nano Silica Retrofitted Cross Beam Specimen

Figure 3.6.4: Testing of Nano Silica Retrofitted Column Specimen

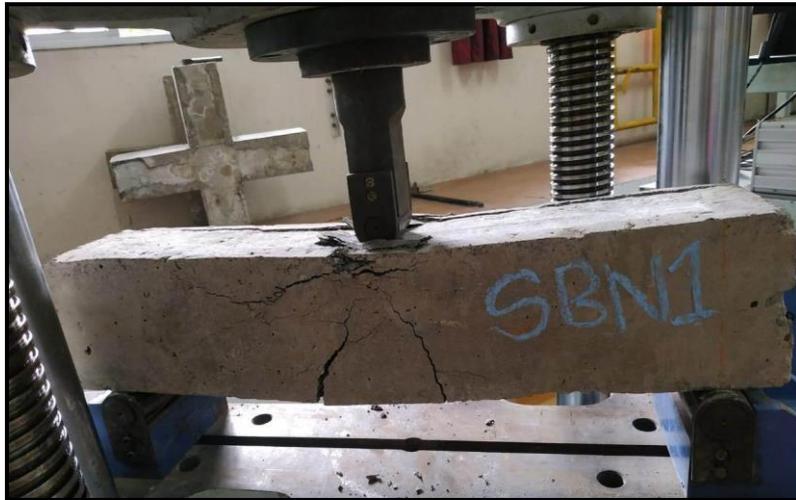
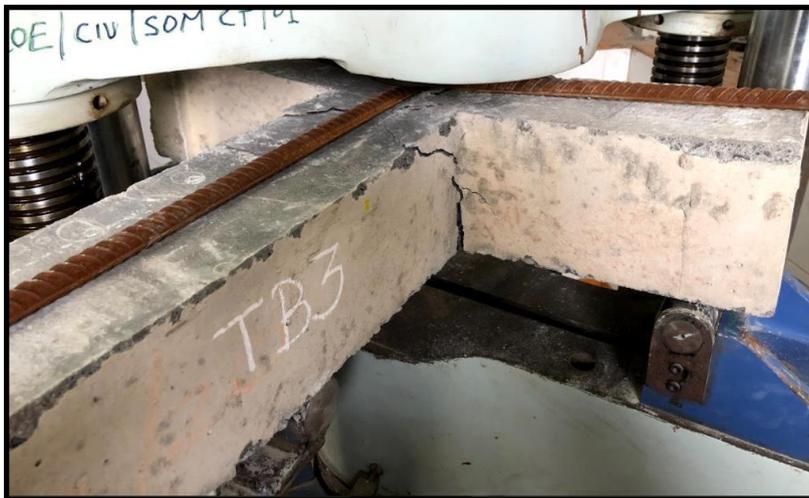
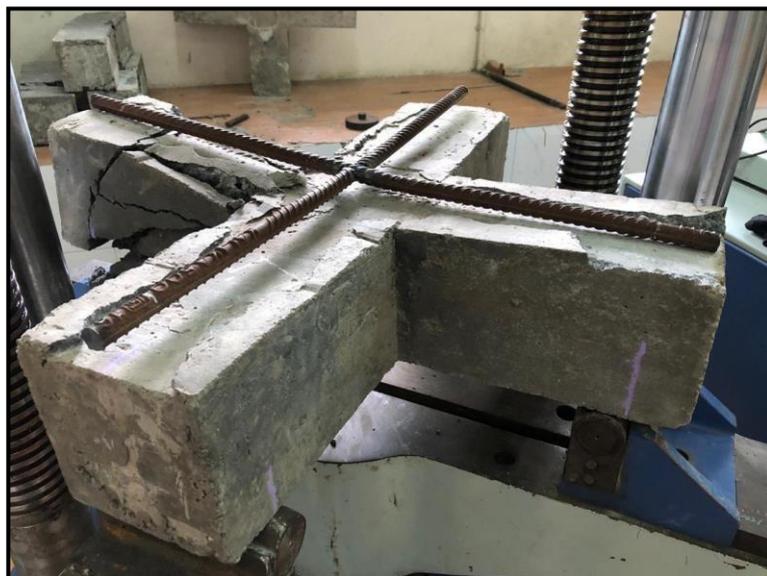
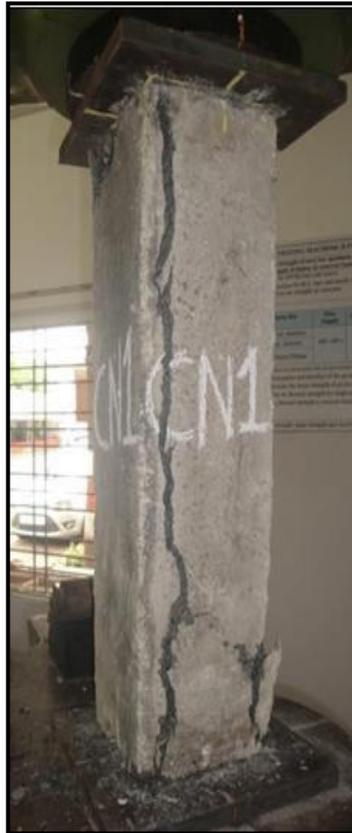
Set II specimens tested for first crack load were retrofitted using nano silica mortar as explained in section 3.8.1. They were retested up to ultimate load carrying capacity and the results of load and respective deflection were withdrawn as given in Table 3.7. Figure 3.7.1, to 3.7.4 shows typical views at complete failure of nano silica retrofitted specimens during tests at ultimate load applied.

Figure3.7.1: Nano Silica Retrofitted Simple Beam Specimen Failure at Ultimate Load

Figure3.7.2: Nano Silica Retrofitted T-Beam Specimen Failure at Ultimate Load

Figure3.7.3: Nano Silica Retrofitted Cross Beam Specimen Failure at Ultimate Load

Figure3.7.4: Nano Silica Retrofitted Column Specimen Failure at Ultimate Load

Sr. No.	Element Name	Ultimate Load(kN)	Deflection(mm)	Average Ultimate Load(kN)	Average Deflection (mm)
1.	RSBN1	97.59	0.94	97.76	0.96
2.	RSBN2	99.06	0.99		
3.	RSBN3	96.64	0.95		
4.	RTBN1	126.04	1.15	122.97	1.16
5.	RTBN2	119.05	1.13		
6.	RTBN3	123.83	1.21		
7.	RCBN1	164.68	0.82	164.77	0.81
8.	RCBN2	159.76	0.79		
9.	RCBN3	169.86	0.81		
10.	RCN1	828.64	2.25	816.87	2.19
11.	RCN2	812.91	2.32		
12.	RCN3	809.06	2.01
