Assessment of Social Sustainability in Urban Regenerated Neighborhoods in the United Arab Emirates: A Local Community Perspective

Department of Architectural Engineering, United Arab Emirates University, Al Ain, Abu Dhabi

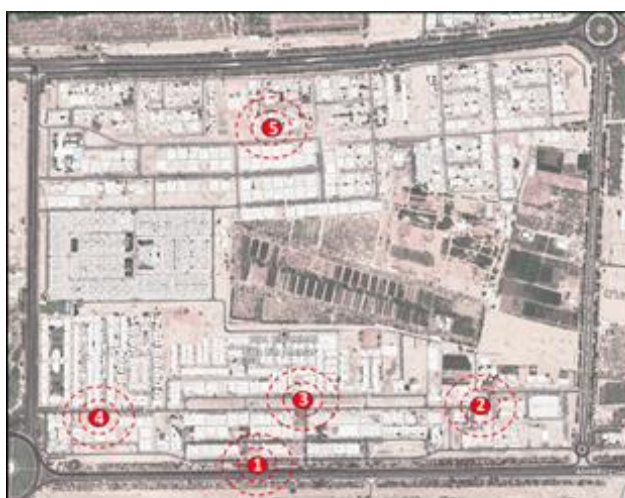
Figure 1. Observed urban spots.

The observer used two techniques, first, participant observation where the observer acted as resident and experienced different urban contexts through walking. Second, recorded behavioral field observation, where the observer recorded behavioral observations while roaming with her car in the neighbourhood. During both observation sessions over two weeks in different timing of the day, WhatsApp mobile application was used to take field notes since it has different ways of capturing information from writing, voice recording and photographs. This allowed the observer to take notes immediately while observing. Also, the used smart phone device enabled the observer to capture high resolution pictures and videos associated with the accurate locational information for each of them. Fig. 2 below shows the main important urban spots that were observed.

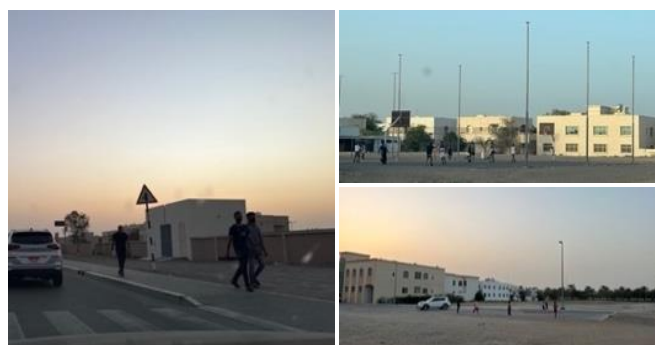
Figure 3a. Existing informal sport activities in vacant plots.

As shown in Figure 3a, basic needs were clearly identified through observation. Many informal youth sport activities were repeatedly noticed in the vacant lots especially in the evening. Sometimes, dead-end streets are also used as playgrounds and cycling activities. Shading by trees were observed at the neighborhood border and through the colonnades of the mixed-used buildings (Figure 3b). The neighborhood contains different commercial activities, such as cafés, restaurants, spas, banks, offices, and private schools. This helped create diverse and available job opportunities.

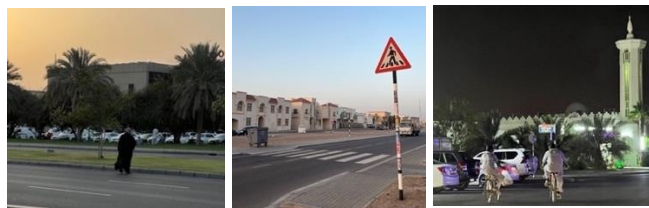
Figure 4. Pedestrian crossing and cycling.

Accessibility, some parts of the neighborhood have been significantly redeveloped while other areas have been noticeably less redeveloped. Pedestrian walkways in the newly developed mixed-used areas are well defined, while there is a lack of well-designed pathways in the less developed area. Still, walking and cycling were frequently noticed towards some facilities especially supermarkets. Moreover, accessibility from some parts of the neighborhood towards the mixed-use area is not well defined either by car or on foot. As shown in Figure 4, there are available pedestrian crossings in the mixed-use area and its surrounding areas. Still, some people cross the road randomly to reach the next neighborhood.

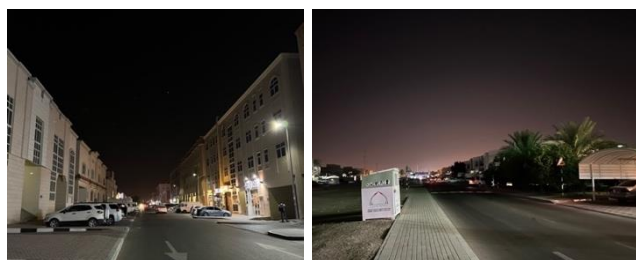
Figure 5. presence of streetlights around mixed-use areas and absence of streetlight in residential plots.

Safety, as shown in Figure 5, in some parts of the neighborhood, especially in the less redeveloped areas, the streets lack sufficient lighting posts where they are lit through the lighting fixtures on the facades of the buildings.

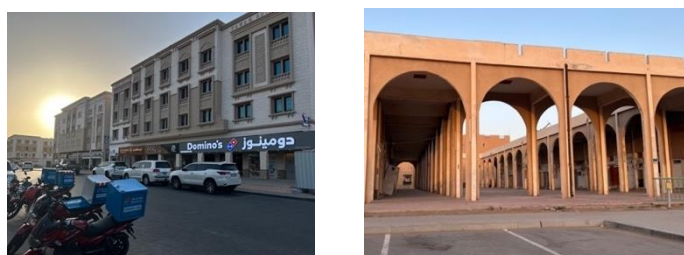
Figure 2. presence of old buildings and the representation of local architecture in the new developments

Sense of Identity: Figure 6 shows the old commercial area which is planned to demolished very soon to be replaced by a new mixed-use building. The architectural design of the new development generally tends to preserve the cultural elements and colors related to the original identity of the place. With the noticeable demographic transformation of the neighborhood from Emirati social housing to market housing many citizens left the neighbourhood and as a result several traditional practices have disappeared including outdoor seating and socializing in front of houses (Majlis). On the other hand, both existing and newly developed mosques are important social gathering spaces after prayers, so this practice is somehow still maintained.

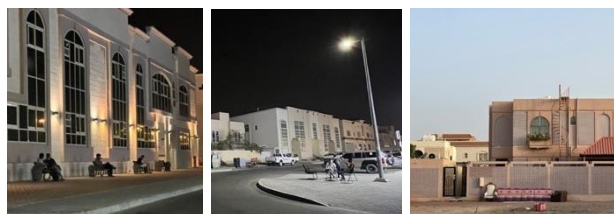
Figure 3. Presence of a few street furnishing to facilitate informal gathering for residents.

Social Coherence: There are no public spaces such as parks and plazas. Hence, residents had to create their own gathering spots as showing in Figure 7. Children play in empty parking area or sandy plots that have not been developed yet.
